Blue Sky Foundation of North Carolina

Evaluation of Energy Efficiency and Moisture Retention in Manufactured Homes in Three North Carolina Counties

Blue Sky Foundation of North Carolina Evaluation of Energy Efficiency and Moisture Retention in Manufactured Homes in Three North Carolina Counties

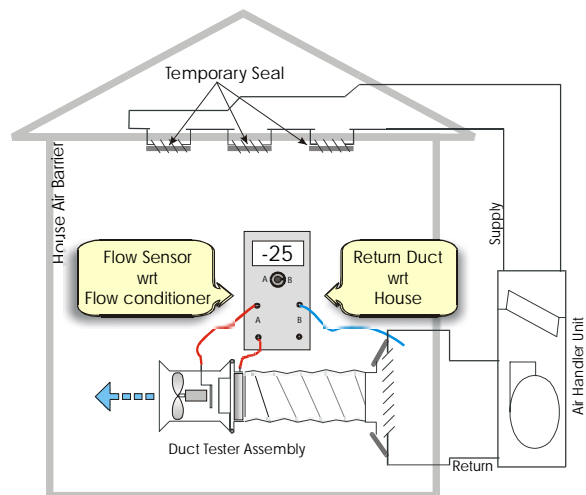
Typical depressurization test. Total CFM25 leakage of the duct system can be determined. A tight system would have leakage rates less than 5% of the rated air handler flow.
